THE SLAUGHTER HOUSE, TIMIȘOARA, ARCHITECT LASZLO SZEKELY

Assoc. Prof. Ph.D. Arch. Ileana KISILEWICZ*

Abstract

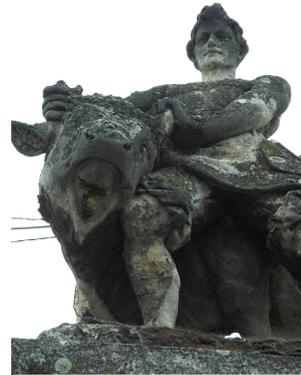
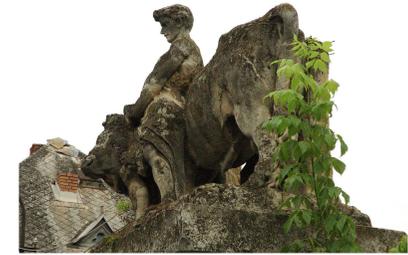
Image 3: The works for the Slaughter House began in 1904 and ended in 1905. The inauguration took place on 1 June 1905. In 2000 the degradation of the ensemble became visible

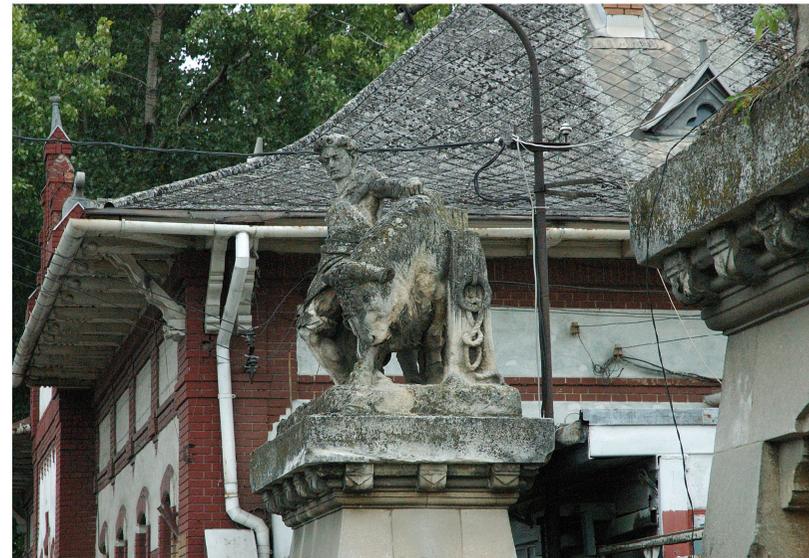
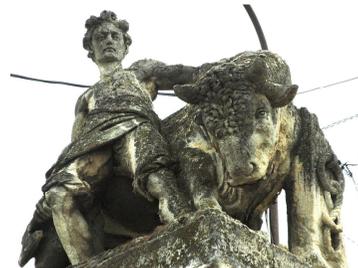
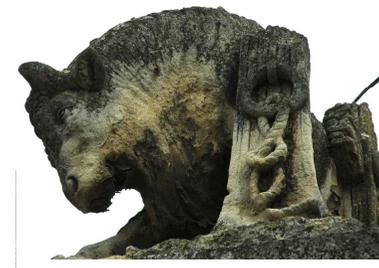
Image 4: Details of decorative sculptures made in artificial stone

The artificial stone surfaces faced biological, chemical and physical decay, in different percentages. The biological decay resulting in microbiological colonization is permanent and very active, with large extension. The chemical decay is the result of the natural reactions of the material under the rain. The physical decay noticed did not affect the general stability of the statues. The most extended pathology recorded was the roughening followed by the microbiological colonization as a result of the non-homogeneous nature of materials as plaster, wood and ceramic tiles. Very well preserved as a material, but not as a surface on facades are the hard-red bricks.

f. Consolidation of artificial stone surfaces. After testing at least 3 products within the site, the most compatible one would be chosen, taking into account its visible effect on the surface.

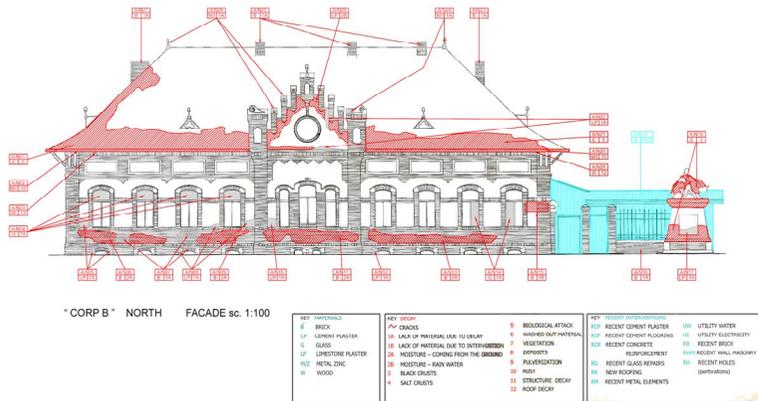
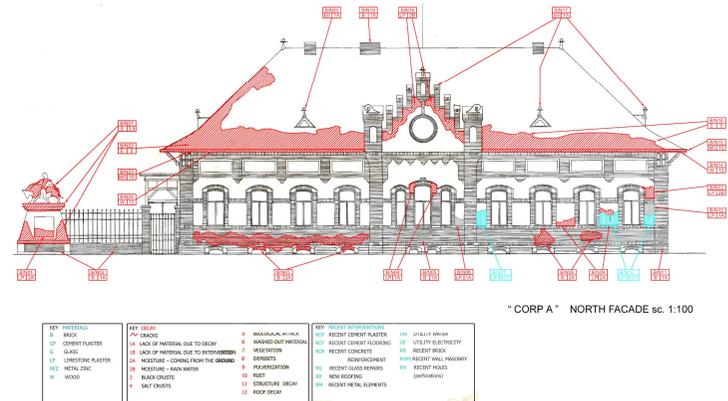
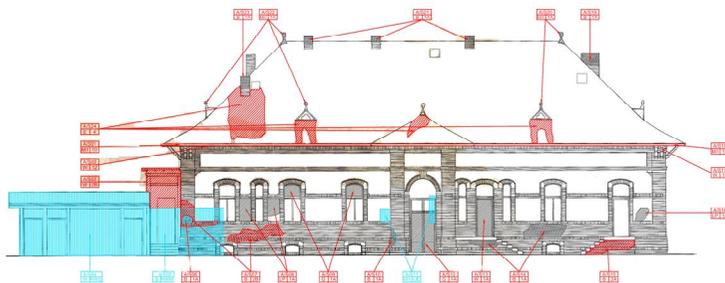
Image 5: Units A & A1 – mapping of decay, construction materials and works

The individual weathering forms were recorded on individual drawings and large photos, illustrated in images 5, 6, 7, and 8. Weathering forms developed individually or one above the other - as in the case of microbiological colonization developed on top of roughening surfaces or on surfaces with detachment on contour scaling, basically on the two sculptures of the main entrance - were noticed.
