**SAXON ARCHITECTURAL HERITAGE IN TRANSYLVANIA**  
**A Research Project: The Ensemble of Sighișoara Fortress - area inscribed**  
**on the World Heritage List – Part I<sup>1</sup>**

*In 2004-2007, the Architecture Faculty of the Spiru Haret University has carried out a complex research of the built environment from the Ensemble of Sighișoara Fortress - area inscribed on the World Heritage List. Results of the research were part of the project Rehabilitation and Revitalization of the Assembly of Sighișoara Fortress, Area included on the World Heritage List, FEASIBILITY STUDY / PART II - building fund and public spaces, included in The National Program of Restoration 2007.*

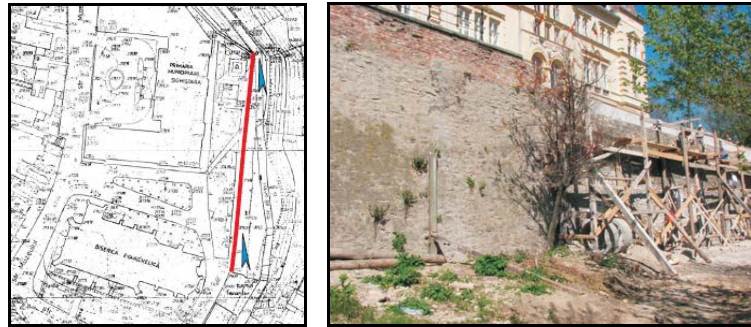
**Fig.4. The fortress wall –Section 1, Plan and image, 2007**

The wall is made of dry stone masonry, and stone and brick masonry bound with lime mortar. The façade is flat and high, with iron railings at the top. There are visible stages of reconstruction and vertical extensions. This section of the wall presents traces of water infiltrations at base and median level. In 2007, building works started on this section.

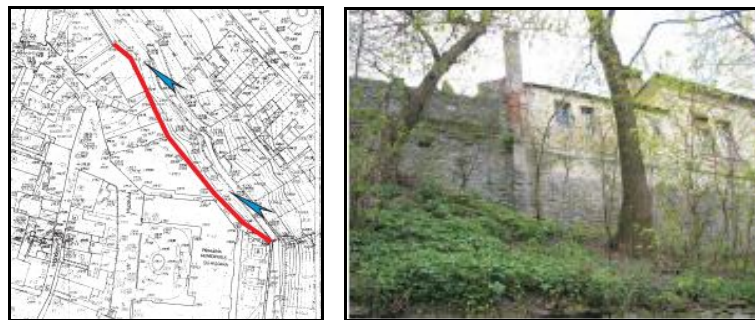
**Fig.5. The fortress wall – Section 2, 3, 4, and 5, Plan and image, 2007**

The façade with average height has parts that were later incorporated into buildings erected next to the wall. This section of the wall shows dislocation of building material generally at the base of the wall. There are visible stages of reconstruction and vertical extensions.

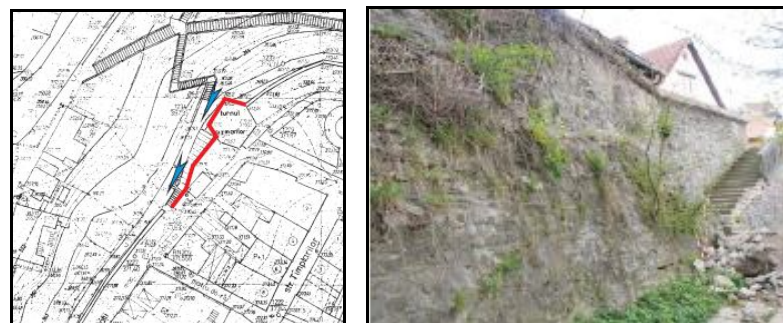
**Fig.6. The fortress wall – Section 9 and 10, Plan and image, 2007**

The wall presents bumps, traces of unequal settlements and major water infiltrations, spontaneous vegetation on large areas, and plaster dislocations. The top of the wall is covered with brick.

This section requires maintenance.

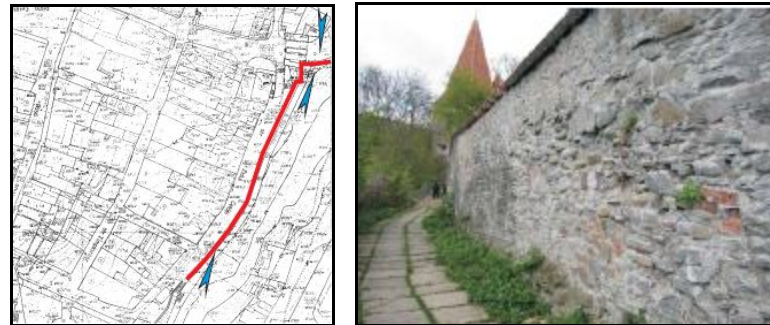
**Fig.7. The fortress wall – Section 11,  
Plan and image, 2007**

The wall is made of dry stone masonry and stone and brick masonry bound with lime mortar. The façade has a relatively flat surface. The top of the wall is covered with ceramic tiles. This section is relatively in a good condition, but the cleaning of vegetation is needed.

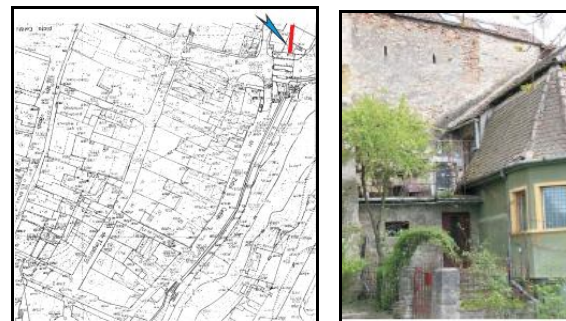
**Fig.8. The fortress wall – Section 12,  
Plan and image, 2007**

The wall is made of dry stone masonry and stone and brick masonry bound with lime mortar. The façade has a relatively flat surface. The top of the wall is covered with ceramic tiles. The wall has a height of about 10-12m and it is partially integrated into buildings. Shooting holes on top are preserved. The elevation of the wall has portions with detached plaster and it is free from infiltrations or vegetation.

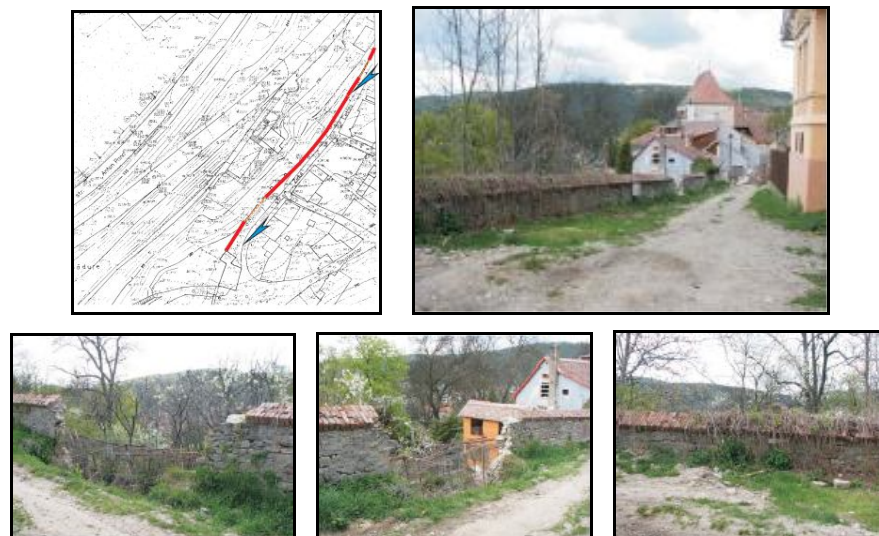
**Fig.9. The fortress wall – Section 13,  
Plan and images, 2007**

The wall is made of dry stone masonry and stone and brick masonry bound with lime mortar. Several portions (irregular shape) of the wall have collapsed at different times, due to lack of maintenance (systematic loss of cohesion of the binder under the action of rainfall). This section of the wall is presently abandoned. One can see the various consolidation attempts, but in the absence of a major intervention, other displacements and collapses of the wall occurred. The preserved parts present cracks in the joints of the materials (stone - brick), bumps and traces of infiltration and vegetation.

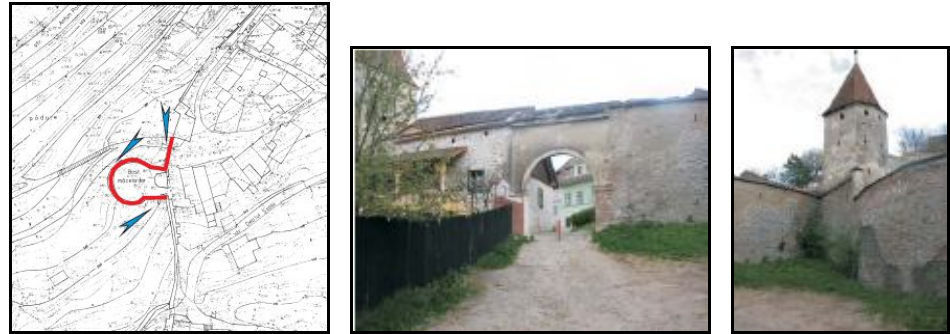
**Fig.10. The fortress wall – Section 14 and 15, Plan and images, 2007**

In this section there is an access known as "Törle" (in German small door). Much of this portion was protected by a potting house. The elevation shows dislocated areas and degradations, especially at the base level.

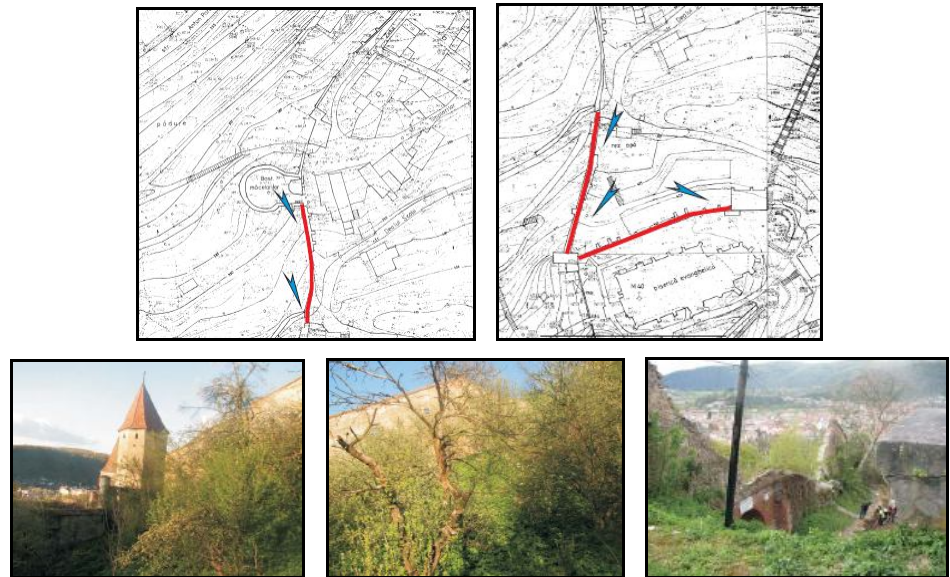
**Fig.11. The fortress wall – Section 16 and 17, Plans and images, 2007**

The wall is made of stone and brick masonry bound with lime mortar. The wall is wider at the bottom, for defensive reasons and in order to support the watch road (similar to the Archer Gallery). There are several bumps and a large part collapsed due to lack of maintenance and the loss of cohesion of the binder material under the systematic action of rain. The watch road is destroyed, especially at the top. These sections of the wall are now abandoned. The two sections are separated from each other by the gateway to the Evangelical Cemetery, this portion being the only one, which has suffered minimum maintenance works.

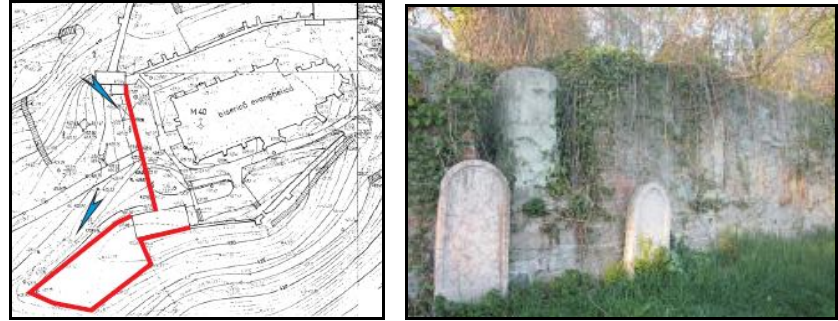
**Fig.12. The fortress wall – Section 18, Plan and image, 2007**

The wall is made of dry stone masonry and stone and brick masonry bound with lime mortar. The section that is part of the Castaldo Bastion has an average height and is covered by abundant vegetation. On the upper part, there is a 2m high protective mesh fence. The face of the wall is made of stone without plastering.

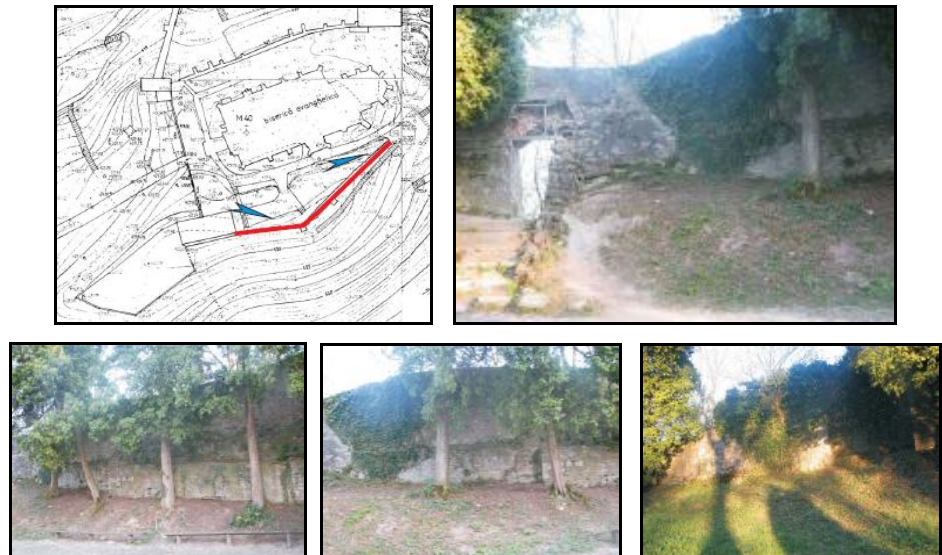
**Fig.13. The fortress wall – Section 19, Plan and images, 2007**

The wall is made of stone and brick masonry bound with lime mortar. The face of the wall is made of stone and it is plastered. This part of the wall has a pedestrian gate crowned by an arch that marks the access. There is significant degradation at the top of the wall. At the base of the wall, there is a thickening - a sign of a previous phase of construction. There are visible infiltrations at the median level and excess vegetation. On the outside of the precinct, there are massive buttresses. Plaster is decayed and there are major dislocations in the masonry.

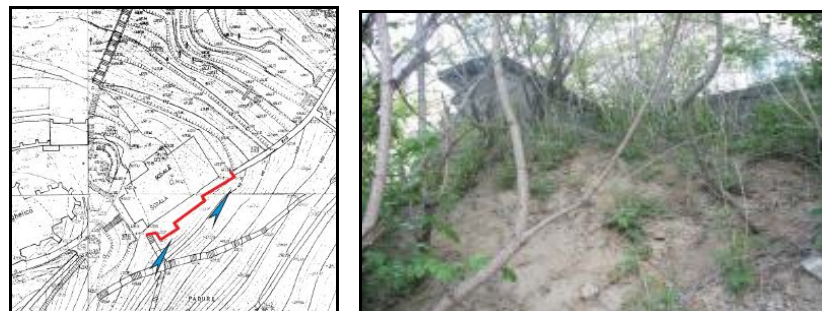
**Fig.14. The fortress wall – Section 20, Plan and image, 2007**

On the outside of the precinct, the wall is made of stone and brick masonry bound with lime mortar. On the inside of the precinct, the face of the wall is made of brick. This portion of the wall was rebuilt, with a lower height. On the outside of the precinct, the wall presents cracks, dislocation of stones, plaster bumps, local collapse, and abundant vegetation.

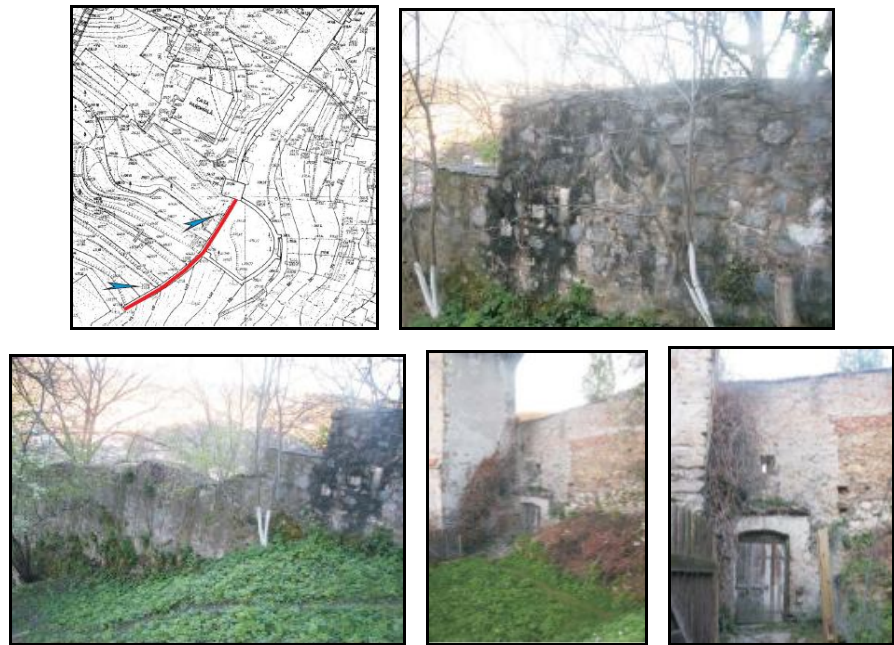
**Fig.15. The fortress wall – Section 21,  
Plan and images, 2007**

This section of the wall has great height and is located on a steep slope. The top of the wall has collapsed. In the area of contact with the ground, there are bumps, infiltrations, and vegetation. Large areas of plaster are fallen.

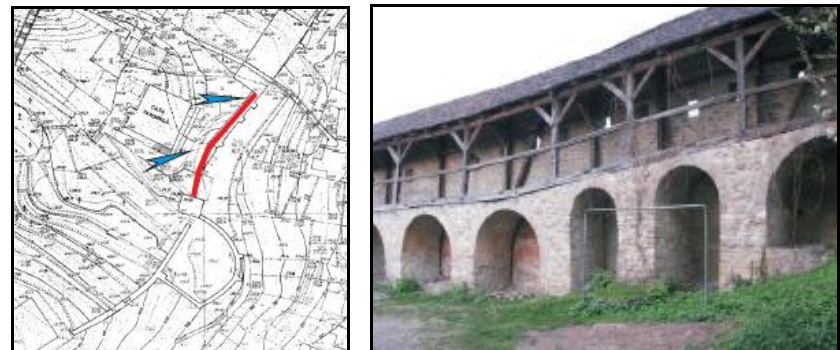
**Fig.16. The fortress wall – Section 22,  
Plan and image, 2007**

The wall is made of stone and brick masonry bound with lime mortar without plaster. This portion of the wall is doubled with masonry arches that support a wooden superstructure of a gallery with tile covering – the Archers Gallery. At the top, the wall is equipped with shooting holes. At the bottom, under the arches, the face of the wall is made of masonry or brick, left apparent or plastered.

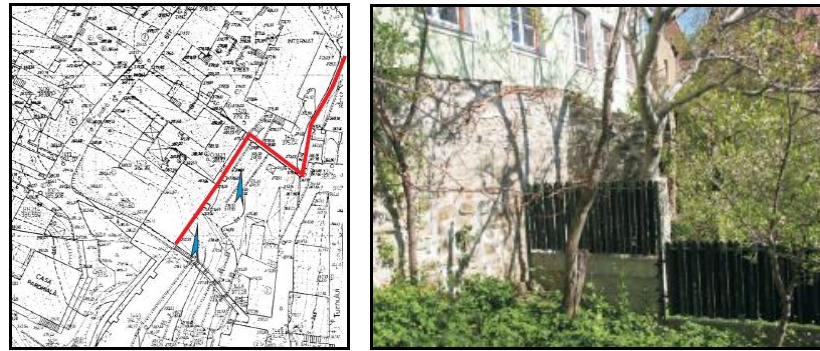
**Fig.17. The fortress wall – Section 23,  
Plan and image, 2007**

The wall is made of stone and brick masonry bound with lime mortar. Portions of this wall are surprisingly well preserved. The traces of consoles, which sustained the former watch road, still can be seen. Part of this section is embodied in a building; the rest having a greater height is still preserved. At the top, the wall has a ceramic cover. The face of wall presents infiltrations, vegetation and bumps on the bottom. The plaster is fallen on large portions.

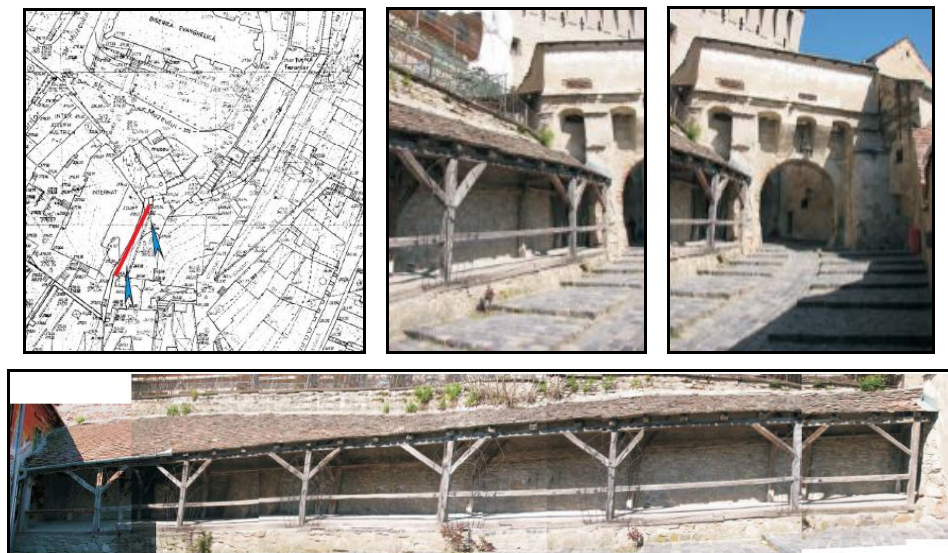
**Fig.18. The fortress wall – Section 24,  
Plan and images, 2007**

The wall is made of stone on the bottom, and brick masonry bound with lime mortar, plastered, on the top – traces of a vertical extension phase. This section has an average height. On the exterior, the wall is doubled with the Elderly Ladies Gallery - a wooden structure with ceramic roofing. An iron railing protected the top of the wall. On the inner sidewall, height is very small, due to large difference in level between the inside and outside; this caused the appearance of vegetation at the top of the wall.

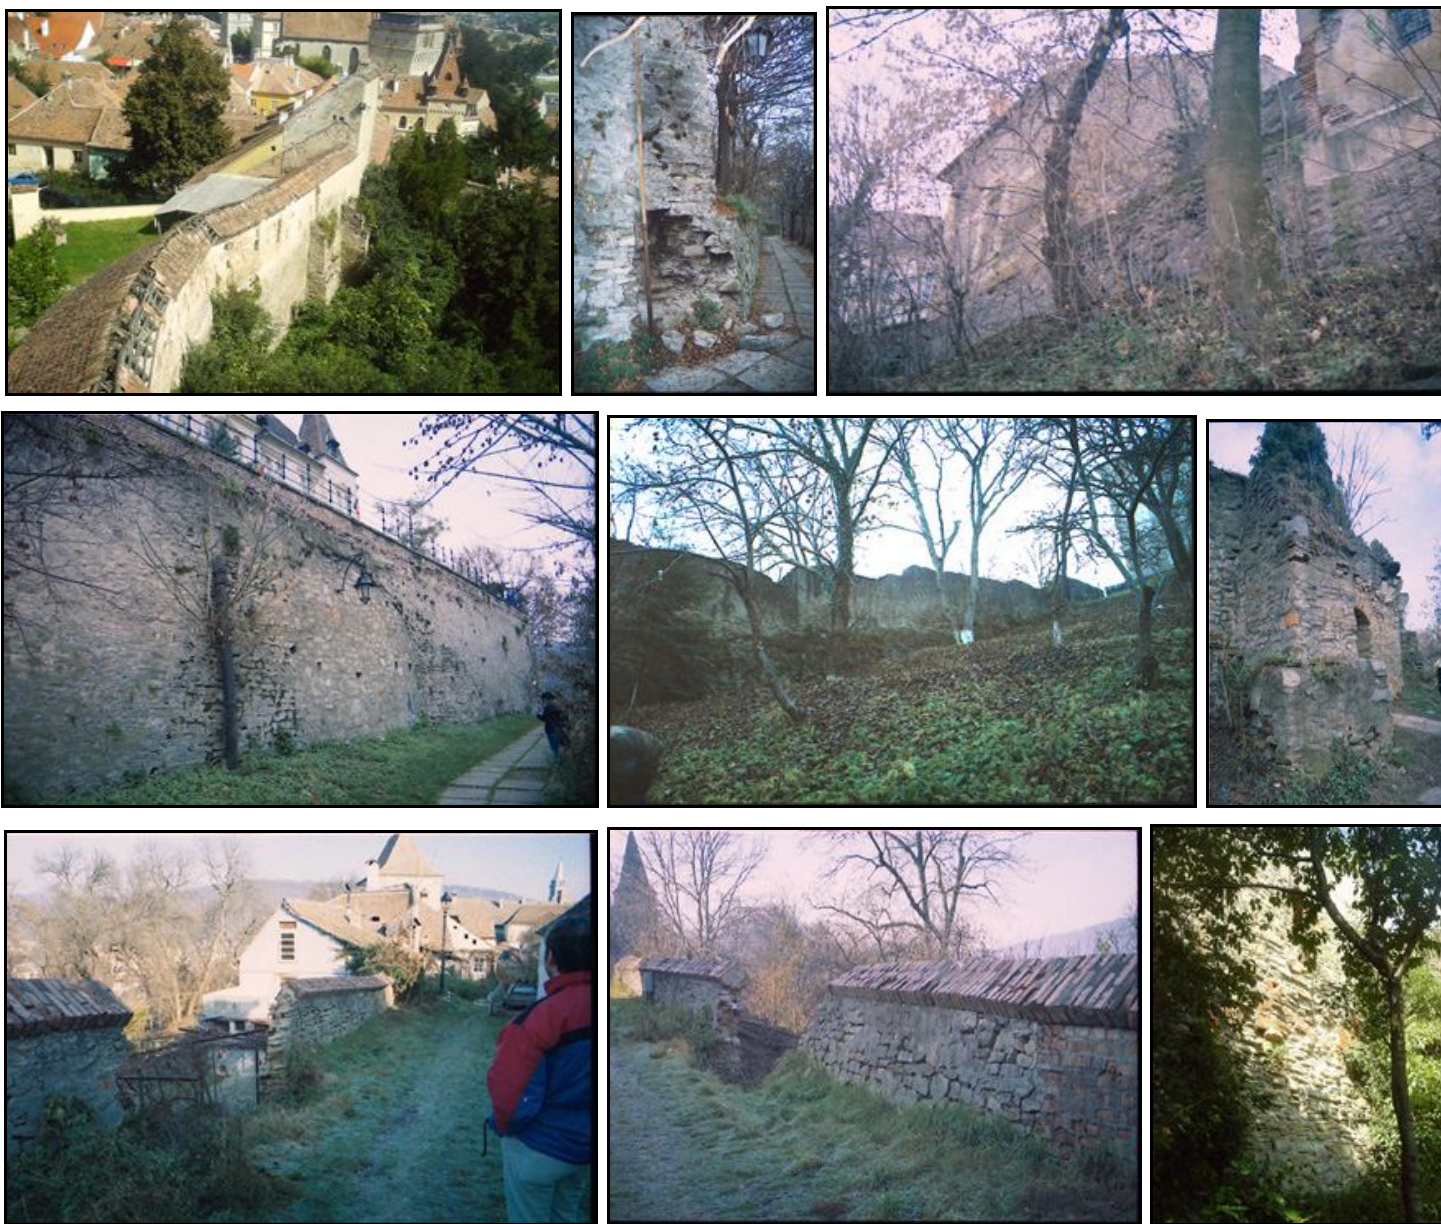
The fortress wall, due to its continuous degradation, presents a high risk of losing its stability and therefore requires immediate interventions.

***Fig.19. Zones that present a high risk of losing its stability and therefore require immediate interventions, 2004-2007***

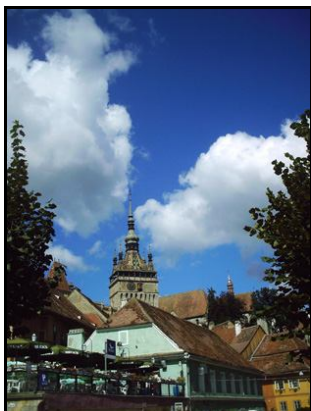
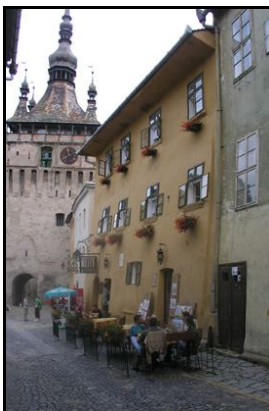
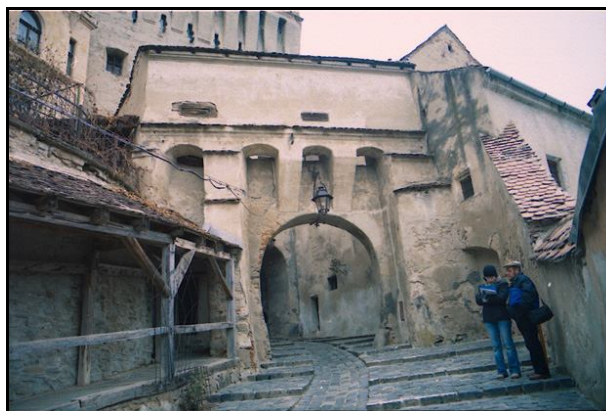
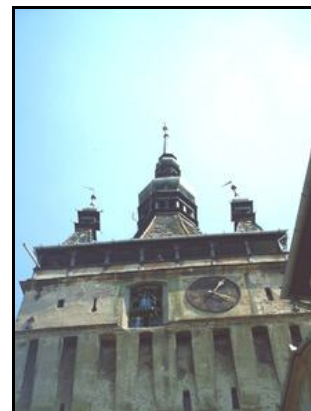
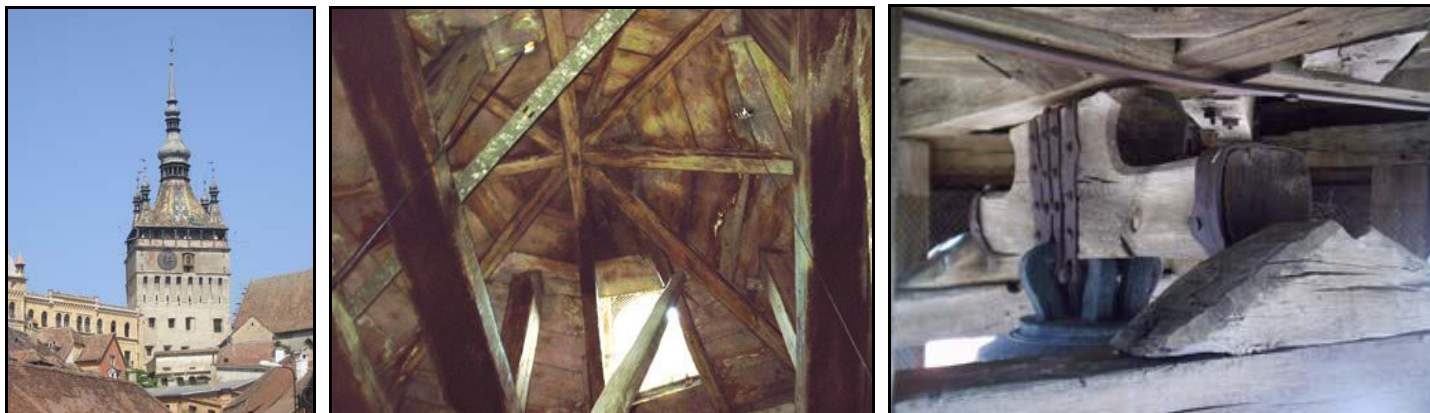
**Fig.21. The Clock Tower, images, 2004-2007**

The tower needs consolidation and restoration works especially on the roof structure and the roofing. There are dislocations and vertical cracks on the northeastern and southwestern elevations between the third and fifth floors. On the interior, there are cracks at the fifth, fourth, and third level, extended to the vault of the entrance gate. A biological expertise is needed to be made on the timber structure.

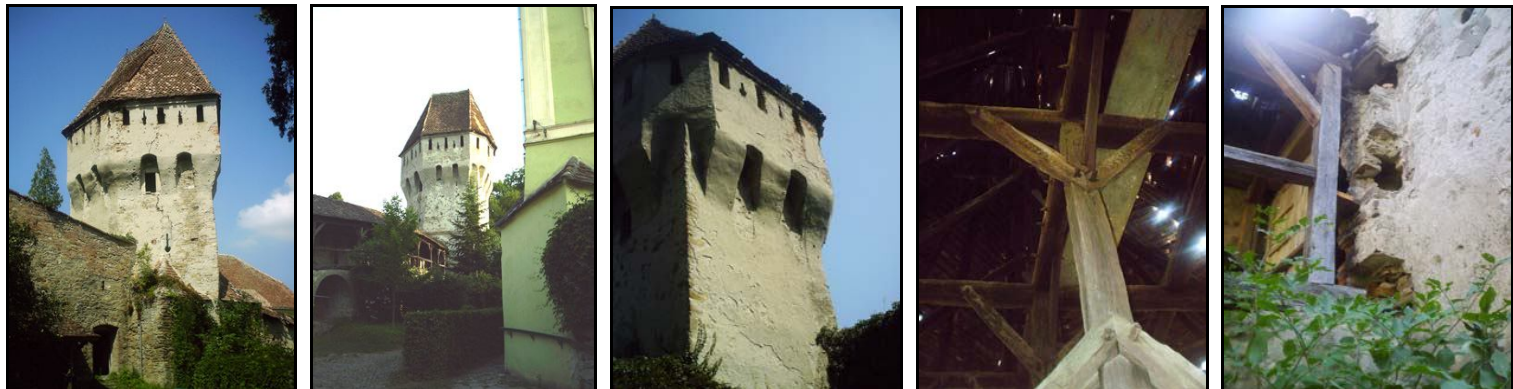
**Fig.24. The Tin-Makers Tower, images, 2004-2007**

The main degradations, visible from both inside and outside, are the almost vertical cracks that run in the area of the openings. Typically, these cracks appear on the outside of the fifth floor, from the cornice to the level of the *machiculis* sustained by brick cantilevers. The tower is separated into vertical segments starting from its upper part, having an additional swelling tendency at the vault over the fourth floor. There are local dislocations of the masonry, probably due to the settling of the ground. The roof structure needs major replacements and the roof tiles are decayed and favor the infiltration of rain.

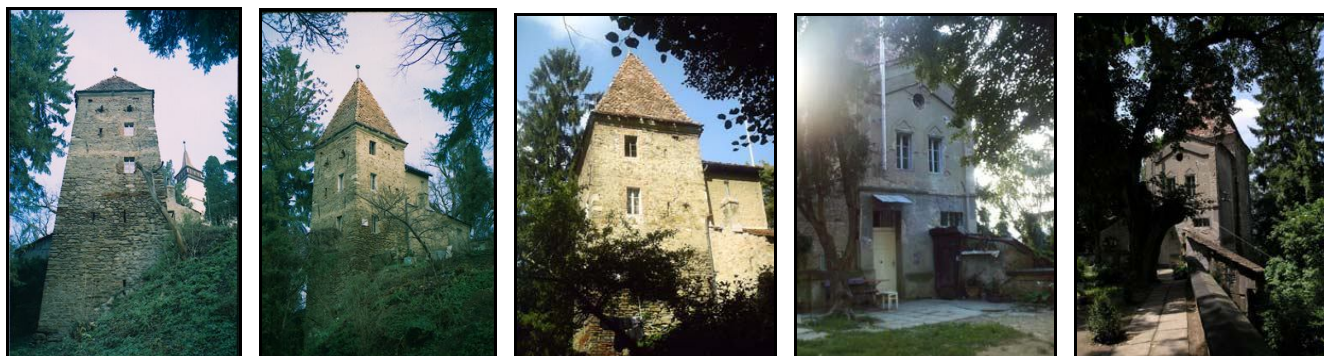
**Fig.26. The Tin-Makers Tower, images, 2004-2007**

The tower has a wide vertical fissure on the northern elevation, decayed plaster and medium degradations on the roof.

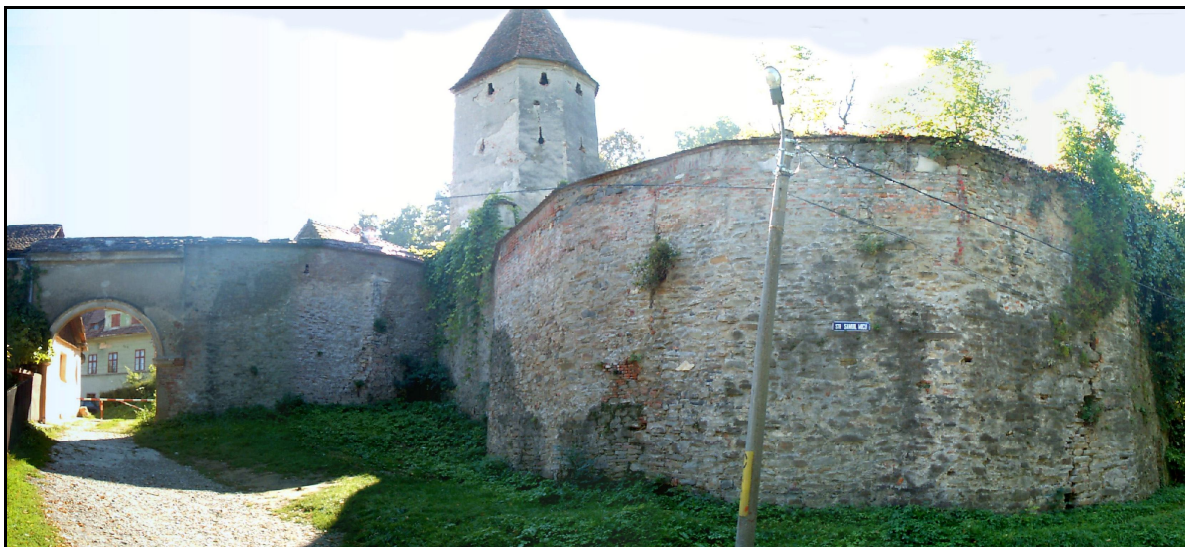
**Fig.28. The Butchers Tower and the (Castaldo) Bastion, images, 2004-2007**

Today the tower is not in use due to its advanced state of degradation.

There are fissures and cracks at the openings, dislocated plaster, and the mortar is washed out of the masonry. The bastion has a crack that runs along its whole height.

The timber roof structure and the roof tiles need reparations and replacements.

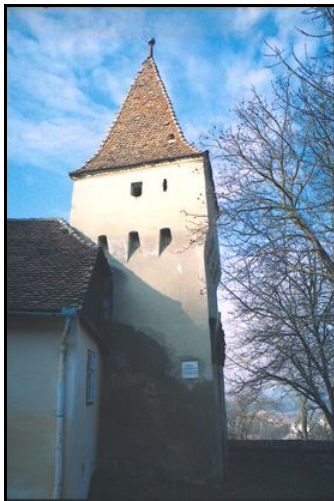
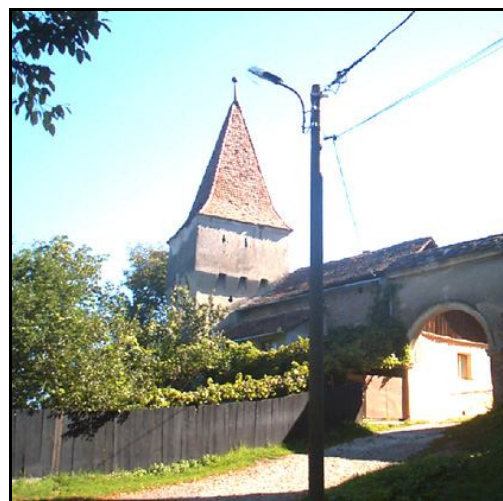
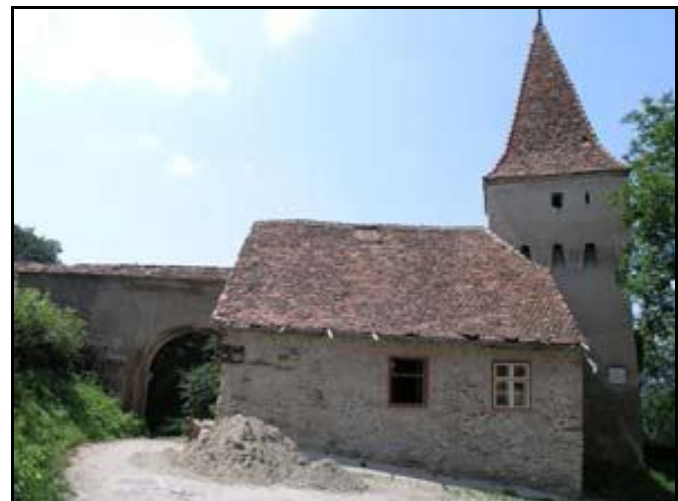
At the bottom of the tower, repairs have been made with cement plaster, at the back of which it is possible to have degradations. There are cracks on the upper part of the tower, at the cornice level.

The roof structure and the roof tiles are in an advanced state of decay. The arch above the entrance to the Fortress that is next to the tower has a typical crack in the centre.

Today the tower is not in use and needs general repair works.

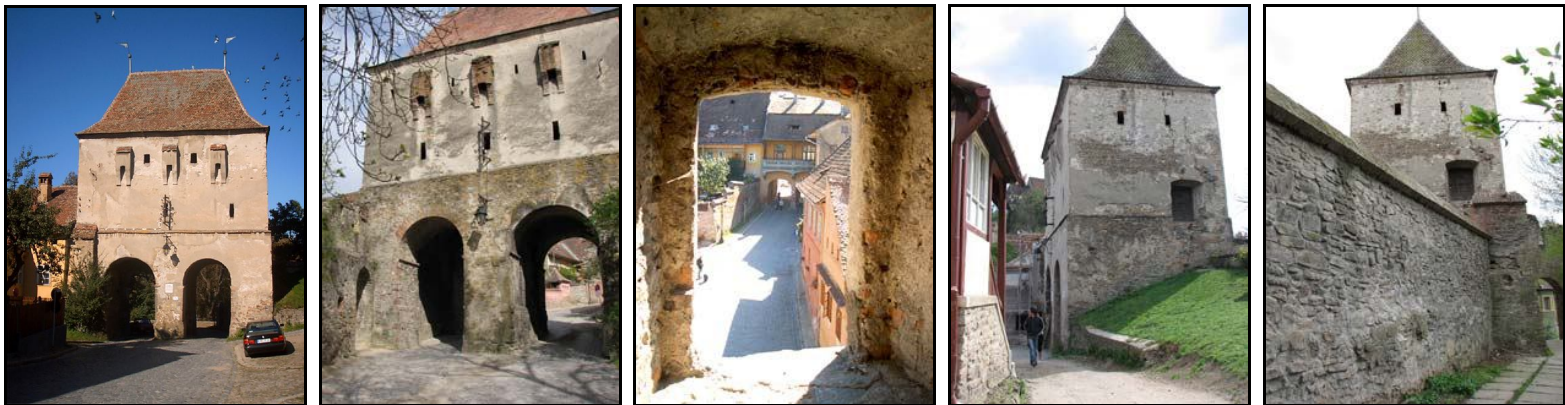
**Fig.32. The Tailors Tower, images, 2004-2007**

The tower has an ample dislocation on its entire elevation – from the cornice to the entrance vault, and further to the foundations. The roof tiles have medium degradations.

The tower was used for the needs of the town and also as a storage place, but currently its precarious state makes it unsafe to use and visit. Today, the two gates permit the access of cars into the fortress, creating vibrations in the structure.

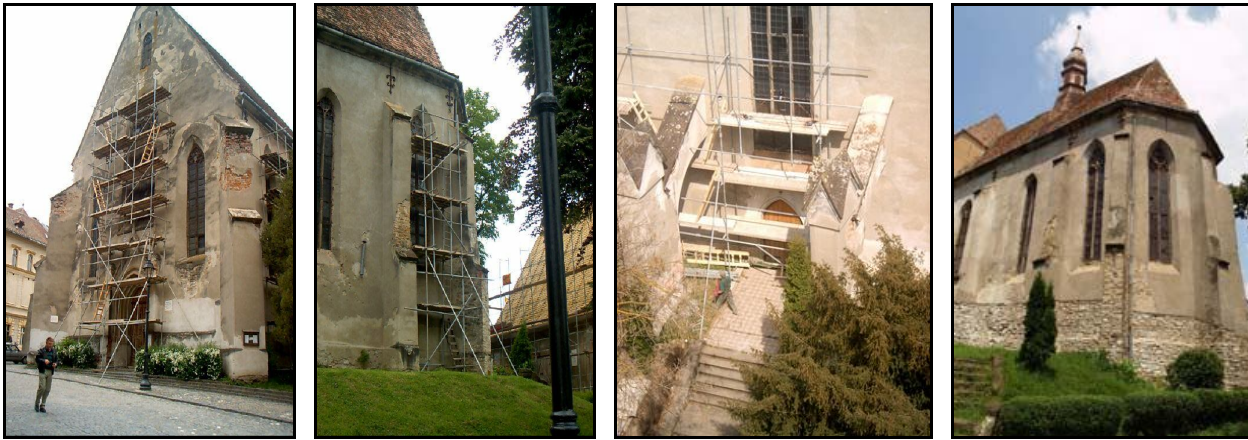
**Fig.42. The Evangelic Church on the Hill, works in process, 2005**

Presently (2007), the state of the exterior of the church, with water infiltrations, missing plaster and exfoliated areas, requires the re-plastering of the entire building. The works are in process, financed by the Evangelic Parish. Before the beginning of the execution works, archeological and façade research has been made.
