**SAXON ARCHITECTURAL HERITAGE IN TRANSYLVANIA**  
**A Research Project: The Ensemble of Sighișoara Fortress - area inscribed**  
**on the World Heritage List – Part I<sup>1</sup>**

*In 2004-2007, the Architecture Faculty of the Spiru Haret University has carried out a complex research of the built environment from the Ensemble of Sighișoara Fortress - area inscribed on the World Heritage List. Results of the research were part of the project Rehabilitation and Revitalization of the Assembly of Sighișoara Fortress, Area included on the World Heritage List, FEASIBILITY STUDY / PART II - building fund and public spaces, included in The National Program of Restoration 2007.*

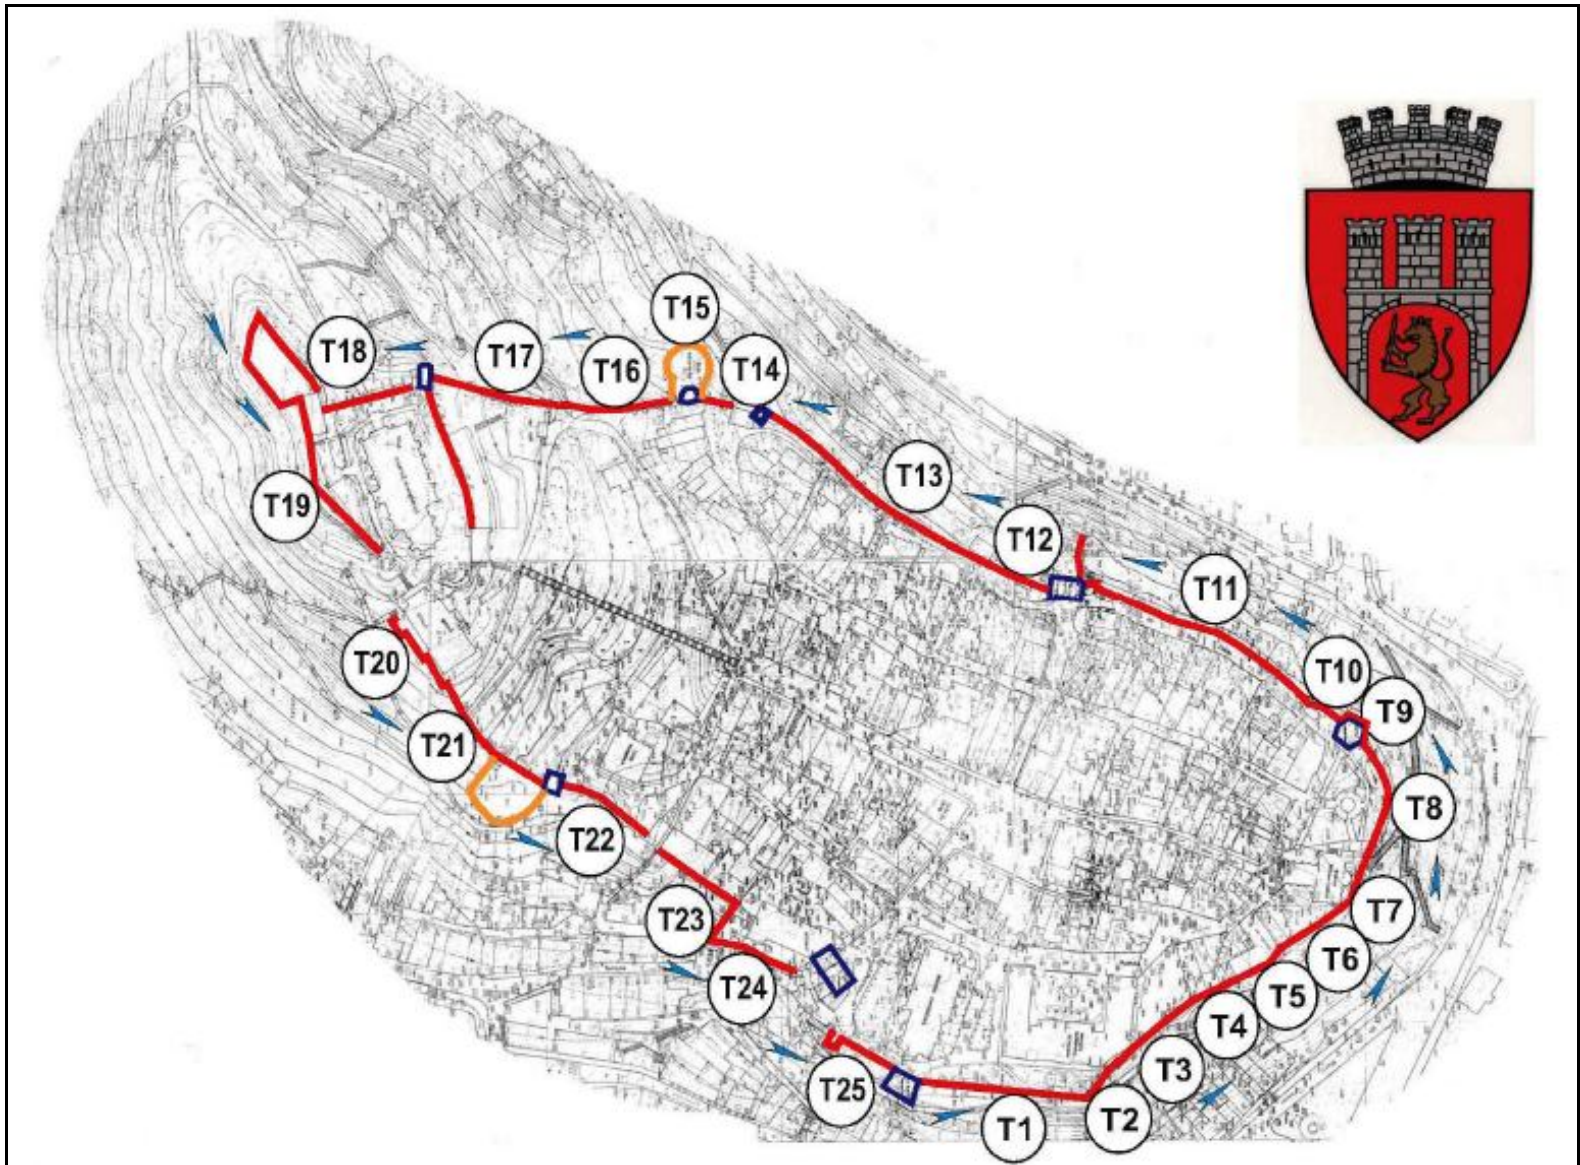
**Fig.3. The fortress wall – Planimetric scheme of the research sections, 2004-2007**

The fortress wall, due to its continuous degradation, presents a high risk of losing its stability and therefore requires immediate interventions.

The city wall, which has a length of about 930 m, with heights ranging from 2 m to 10 m, was researched in 25 sections.

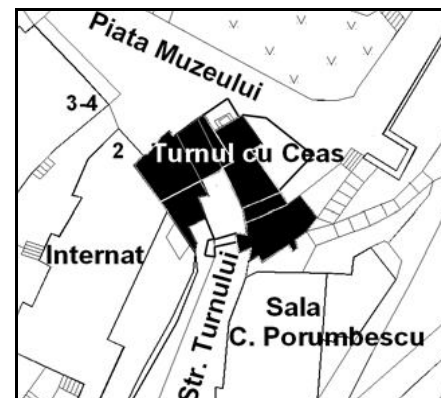
**Fig.20. The Clock Tower, plan**

The plan of the tower is a 14.00 m x 8.66 m rectangle, with a vaulted ground floor and five floors. The last floor is retired with 1.4 m and surrounded by a timber gallery. The foundations are made of stone, the structure is out of brick and stone, the floors are made of timber, the interior staircases are made of brick and timber, the roof has a timber structure, and the roofing is made out of ceramic plates and tin plates on the spires.

The tower needs consolidation and restoration works especially on the roof structure and the roofing. There are dislocations and vertical cracks on the northeastern and southwestern elevations between the third and fifth floors. On the interior, there are cracks at the fifth, fourth, and third level, extended to the vault of the entrance gate. A biological expertise is needed to be made on the timber structure.

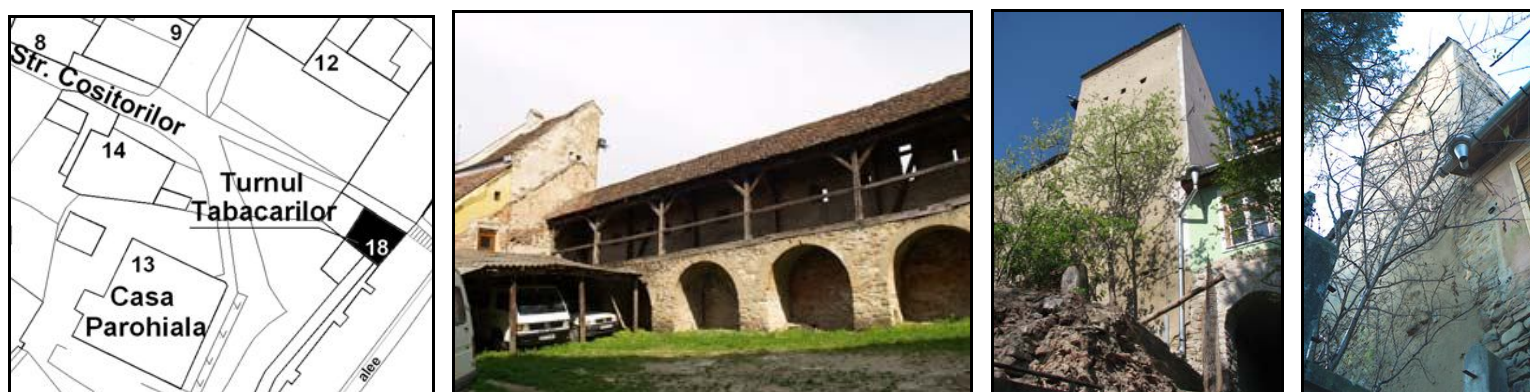
**Fig.22. The Tanners Tower, plan and images, 2004-2007**

There are no visible degradations, only dislocated plasters.

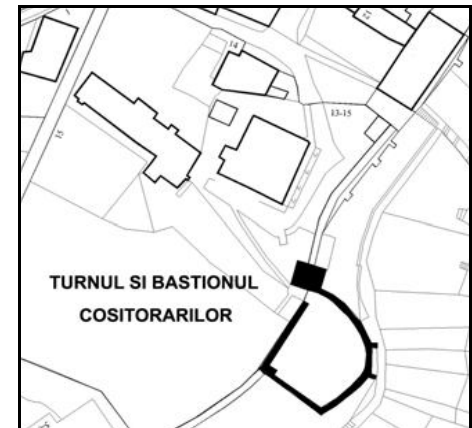
**Fig.23. The Tin-Makers Tower, plan**

From the structural point of view, the tower and the bastion are in an extremely fragile state, close to collapse, the access to the tower being closed.

The main degradations, visible from both inside and outside, are the almost vertical cracks that run in the area of the openings. Typically, these cracks appear on the outside of the fifth floor, from the cornice to the level of the *machiculis* sustained by brick cantilevers. The tower is separated into vertical segments starting from its upper part, having an additional swelling tendency at the vault over the fourth floor. There are local dislocations of the masonry, probably due to the settling of the ground. The roof structure needs major replacements and the roof tiles are decayed and favor the infiltration of rain.

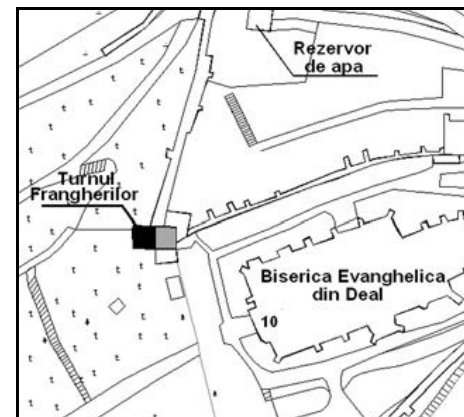
**Fig.25. The Rope Makers Tower, plan**

The tower has a wide vertical fissure on the northern elevation, decayed plaster and medium degradations on the roof.

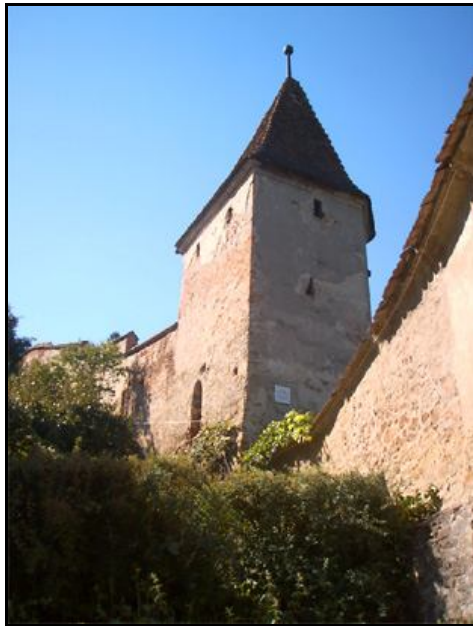
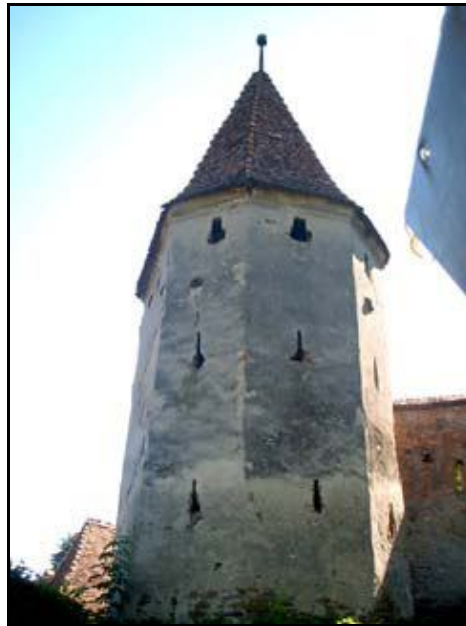
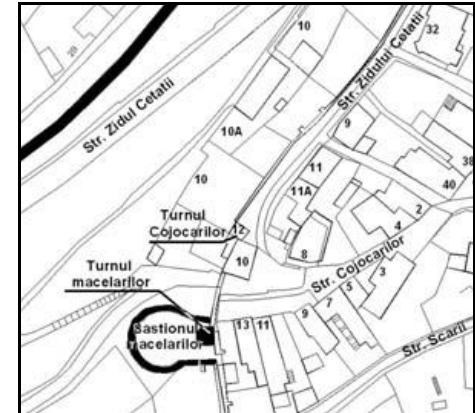
**Fig.27. The Butchers Tower and the (Castaldo) Bastion, plan**

Today the tower is not in use due to its advanced state of degradation.

There are fissures and cracks at the openings, dislocated plaster, and the mortar is washed out of the masonry. The bastion has a crack that runs along its whole height.

The timber roof structure and the roof tiles need reparations and replacements.

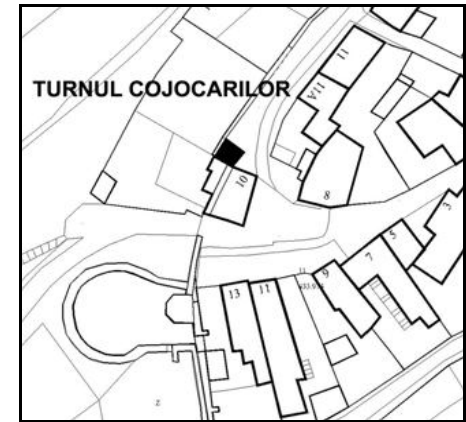
**Fig.29. The Furriers Tower, plan**

At the bottom of the tower, repairs have been made with cement plaster, at the back of which it is possible to have degradations. There are cracks on the upper part of the tower, at the cornice level.

The roof structure and the roof tiles are in an advanced state of decay. The arch above the entrance to the Fortress that is next to the tower has a typical crack in the centre.

Today the tower is not in use and needs general repair works.

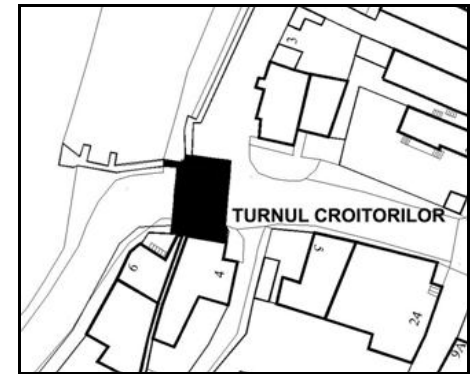
**Fig.31. The Tailors Tower, plan**

The tower has an ample dislocation on its entire elevation – from the cornice to the entrance vault, and further to the foundations. The roof tiles have medium degradations.

The tower was used for the needs of the town and also as a storage place, but currently its precarious state makes it unsafe to use and visit. Today, the two gates permit the access of cars into the fortress, creating vibrations in the structure.

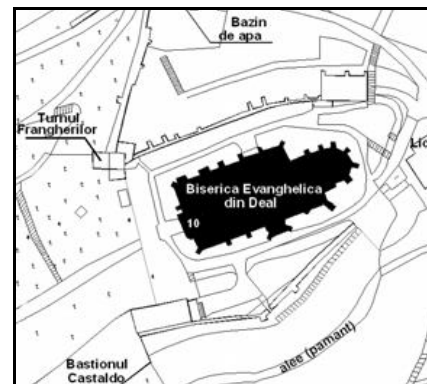
**Fig.38. The Evangelical Church on the Hill, plan**

During the 20<sup>th</sup> century, because of the massive immigration of the Saxon community from Sighișoara, a general phenomenon in Transylvania, the church diminished religious activity, used only temporarily. Without parishioners, a slow but constant decay was produced. Cracks started to appear on the walls and vaults and the roof has started to deteriorate - biologically and physically.

Between 1992 and 2004, ample restoration works have been initiated on the church, co-financed by the *Ministry of Culture* and the *Messerschmitt München Foundation*. The structural interventions are partly reversible and completely invisible:

- consolidation of the structure by introducing metallic bars into holes drilled into the walls
- consolidation of the vaults with metallic laminated profiles anchored into the perimeter walls and supported by the columns of the hall
- repair and consolidation of the roof structure and renewal of the roofing
- re-plastering of the facades and painting it into light ochre
- restoration of the choir sculptures and of the gothic stone works
- restoration of the frescoes
- restoration of the furniture, paving of the hall with stone slabs
- rehabilitation of the surrounding area by the renewal of the stone paving and creating an exterior sewage system that collects the rain water and eliminates humidity

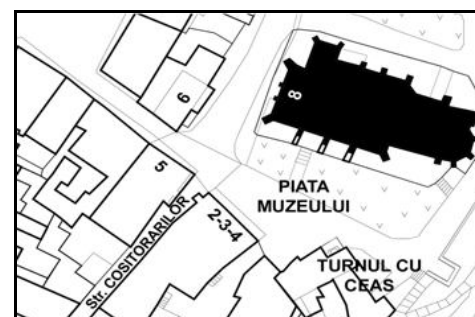
**Fig.41. The Evangelic Church, plan**

Presently (2007), the state of the exterior of the church, with water infiltrations, missing plaster and exfoliated areas, requires the re-plastering of the entire building. The works are in process, financed by the Evangelic Parish. Before the beginning of the execution works, archeological and façade research has been made.
